**Flood Control Project Maintenance
Levee Inspections**
LMA District Cover Sheet
Spring 2017 Levee Inspection Results

Reclamation District No. 1001 Nicolaus

Unit Cover Sheet

Spring 2017 Levee Inspection Results

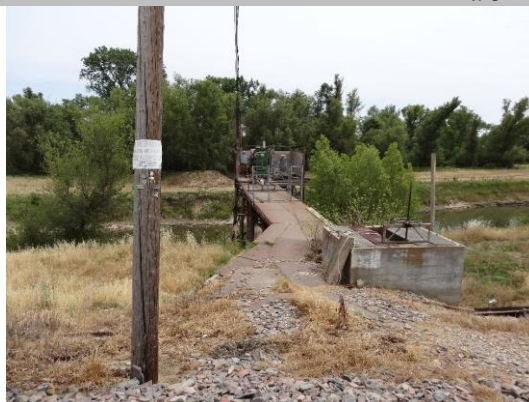
Photo 1 of 3 : UCIP_SP_2017_14472_23891.jpg

LM Start	3.81	Rating **	M	Issue No.	20
LM End	3.81	Issue Type +	En	Location *	LS
Category	Supplemental			GPS Latitude/Longitude	
				Start	End
Item	DWR UCIP Field Study			38.817175 °	38.817175 °
				-121.552946 °	-121.552946 °
DWR ID					
Comment Code					
Inspector Comment					
FS_ID:14472 DS_ID:22613 EP_NO: 1896 Repair Type: Non-Urgent Crossing Status: Found UCIP Comments: - slide gate in concrete box on waterside levee toe.- cracked headwall on landside- working during field survey FIELD_STRUCT_DESC: 2 of 3: Three pipes, a 32-inch and two 20-inch steel pipe through the levee, 2.13 feet below the crown, two vertical pumps on a wooden piling structure in the stream, walkway to the pumps, slide gate in a concrete box on the waterward side (Permit No. 1896) FS Date: 5/15/2013

WS- pump station, walkway, and slide gate in concrete box on levee toe

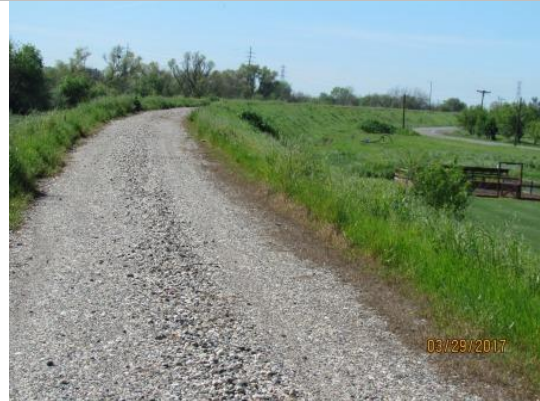
Photo 1 of 1 : SP_2017_RD1001_40_17_20170403_00039.jpg

LM Start	0.00	Rating **	U	Issue No.	17
LM End	1.03	Issue Type +	Ma	Location *	LS
Category	Earthen Levee			GPS Latitude/Longitude	
				Start	End
Item	Vegetation			38.831116 °	38.845278 °
				-121.529687 °	-121.524364 °
DWR ID	DWR_RD1001_06_s_2017_17				
Comment Code					
V1 : Control annual grass and weeds on the levee slopes and easements.					
Inspector Comment					
Maintain annual vegetation, Spring 2017.

View looking downstream of annual vegetation, Spring 2017.

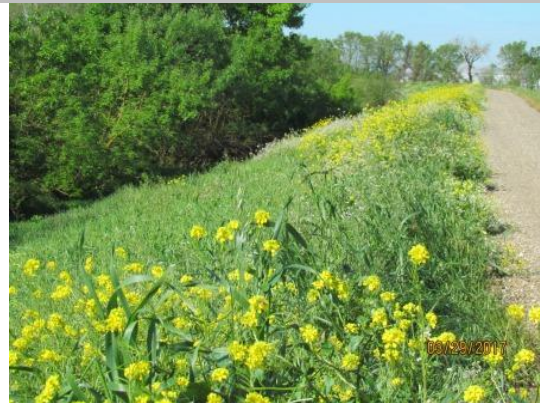
Photo 1 of 1 : SP_2017_RD1001_40_15_20170403_00037.jpg

LM Start	0.00	Rating **	U	Issue No.	15
LM End	4.73	Issue Type +	Ma	Location *	WS
Category	Earthen Levee			GPS Latitude/Longitude	
				Start	End
Item	Vegetation			38.831116 °	38.896371 °
				-121.529687 °	-121.520364 °
DWR ID	DWR_RD1001_06_s_2017_15				
Comment Code					
V1 : Control annual grass and weeds on the levee slopes and easements.					
Inspector Comment					
Maintain annual vegetation, Spring 2017.

View looking downstream of annual vegetation, Spring 2017.

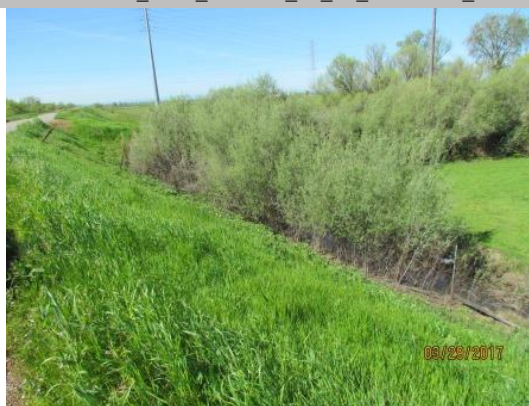
Photo 2 of 2 : SP_2017_RD1001_40_18_20170403_00040.jpg

LM Start	0.01	Rating **	U	Issue No.	18 (cont)	
LM End	0.01	Issue Type +	Ma	Location *	LS	
Category	Earthen Levee			GPS Latitude/Longitude		
				Start		End
Item	Trim / Thin Trees			38.831192 °		38.831192 °
				-121.529580 °		-121.529580 °
DWR ID	DWR_RD1001_06_s_2016_18					
Comment Code						
T3 : Trim and thin trees to allow visibility of the ground and room to flood fight.						
Inspector Comment

View looking downstream of trees that need to be trimmed for visibility on the landside, Spring 2017.

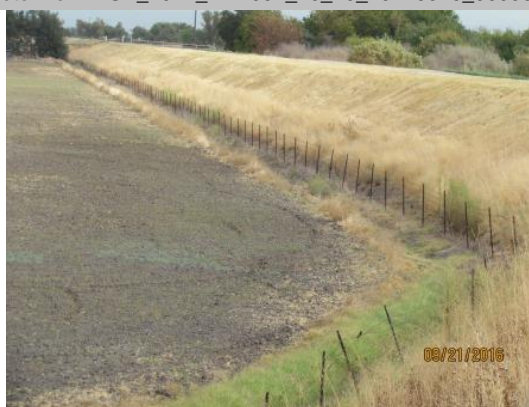
Photo 1 of 1 : SP_2017_RD1001_40_20_20170316_00006.jpg

LM Start	0.02	Rating **	M	Issue No.	20
LM End	0.43	Issue Type +	En	Location *	LS
Category	Earthen Levee			GPS Latitude/Longitude	
				Start	End
Item	Encroachments			38.831243 °	38.836832 °
				-121.529519 °	-121.526810 °
DWR ID	DWR_RD1001_06_f_2016_20				
Comment Code					
FE : Fence					
Inspector Comment					
Fence along the landside levee toe.

View of fence along the landside levee toe looking upstream. Fall 2016.

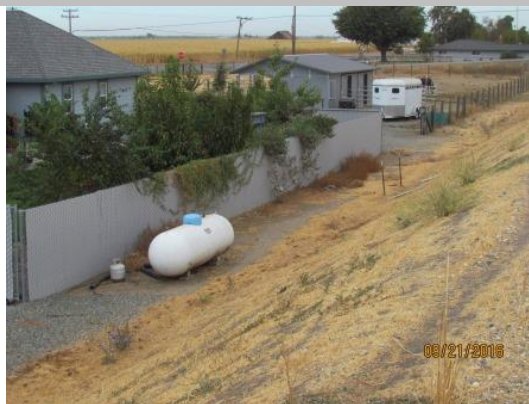
Photo 1 of 1 : SP_2017_RD1001_40_46_20170316_00010.jpg

LM Start	0.95	Rating **	M	Issue No.	46
LM End	0.95	Issue Type +	En	Location *	LS
Category	Earthen Levee			GPS Latitude/Longitude	
				Start	End
Item	Encroachments			38.844109 °	38.844109 °
				-121.524375 °	-121.524375 °
DWR ID	DWR_RD1001_06_s_2012_46				
Comment Code					
TA : Tank					
Inspector Comment

View of a propane tank that is within the landside easement of the levee. Fall 2016.

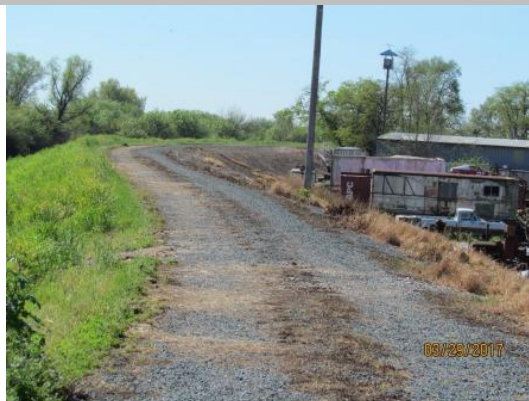
Photo 1 of 1 : SP_2017_RD1001_40_16_20170403_00038.jpg

LM Start	1.03	Rating **	A/W	Issue No.	16
LM End	1.55	Issue Type +	Ma	Location *	LS
Category	Earthen Levee			GPS Latitude/Longitude	
				Start	End
Item	Vegetation			38.845178 °	38.852692 °
				-121.524382 °	-121.524866 °
DWR ID	DWR_RD1001_06_s_2017_16				
Comment Code					
V1 : Control annual grass and weeds on the levee slopes and easements.					
Inspector Comment					
Well maintained annual grasses, Spring 2017.

View looking downstream of well maintained annual grasses, Spring 2017.

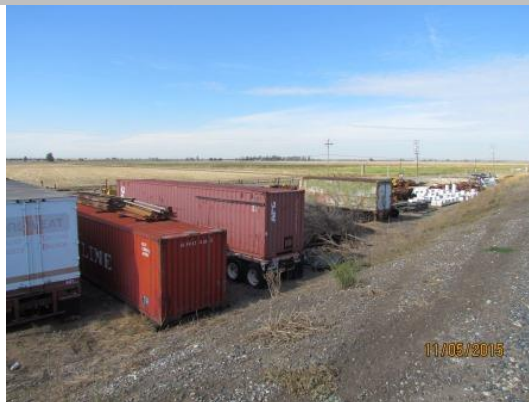
Photo 1 of 1 : SP_2017_RD1001_40_3_20170316_00001.jpg

LM Start	1.43	Rating **	M	Issue No.	3
LM End	1.53	Issue Type +	En	Location *	LS
Category	Earthen Levee			GPS Latitude/Longitude	
				Start	End
Item	Encroachments			38.850945 °	38.852445 °
				-121.524392 °	-121.524809 °
DWR ID	DWR_RD1001_06_s_2012_3				
Comment Code					
EQ : Equipment					
Inspector Comment

View of the equipment at the landside levee toe.

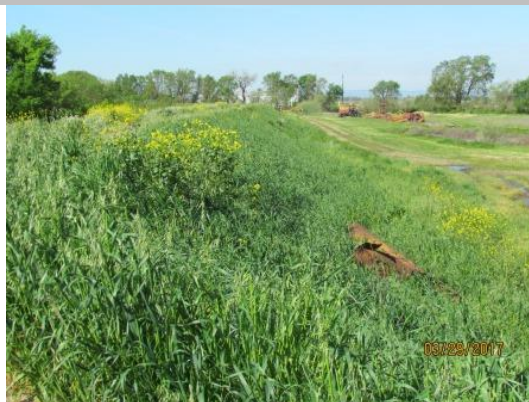
Photo 1 of 1 : SP_2017_RD1001_40_14_20170403_00036.jpg

LM Start	1.55	Rating **	U	Issue No.	14
LM End	4.73	Issue Type +	Ma	Location *	LS
Category	Earthen Levee			GPS Latitude/Longitude	
				Start	End
Item	Vegetation			38.852692 °	38.896370 °
				-121.524866 °	-121.520364 °
DWR ID	DWR_RD1001_06_s_2017_14				
Comment Code					
V1 : Control annual grass and weeds on the levee slopes and easements.					
Inspector Comment					
Maintain annual vegetation, Spring 2017.

View looking downstream of annual vegetation, Spring 2017.

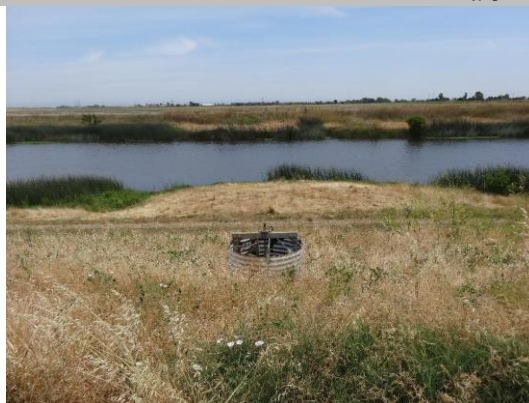
Photo 1 of 3 : UCIP_SP_2017_14244_23467.jpg

LM Start	1.72	Rating **	M	Issue No.	47
LM End	1.72	Issue Type +	En	Location *	LS
Category	Supplemental			GPS Latitude/Longitude	
				Start	End
Item	DWR UCIP Field Study			38.855186 °	38.855186 °
				-121.524895 °	-121.524895 °
DWR ID					
Comment Code					
Inspector Comment					
FS_ID:14244					
DS_ID:22617					
EP_NO: N/A					
Repair Type: Non-Urgent					
Crossing Status: Found					
UCIP Comments: - visible damage to pipe on opening at inlet due to high corrosion.- video inspection recommended.					
FIELD_STRUCT_DESC: 36-inch corrugated-metal drainage pipe through the levee, 12.5 feet below the crown, slide gate in a 48-inch corrugated-metal pipe riser on the waterward slope, concrete headwall at the landward toe, the pipe crosses under the channel.					
FS Date: 5/15/2013

WS- slide gate in CMP riser on levee slope.

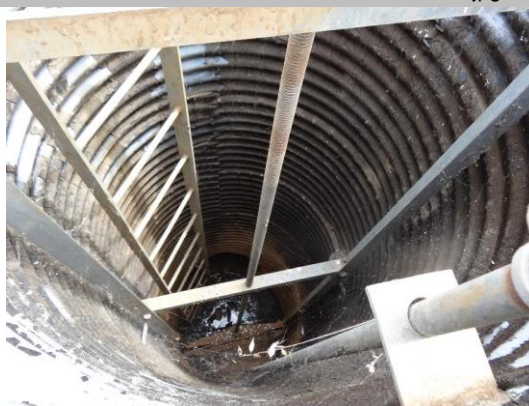
Photo 2 of 3 : UCIP_SP_2017_14244_23466.jpg

WS- slide gate, air vent pipe in CMP riser on levee slope.

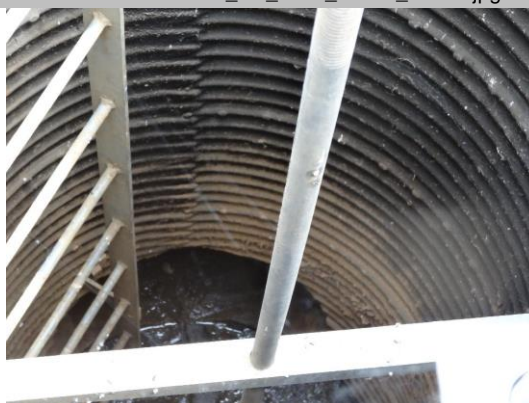
Photo 3 of 3 : UCIP_SP_2017_14244_23465.jpg

WS- pipe opening visible inside CMP riser.

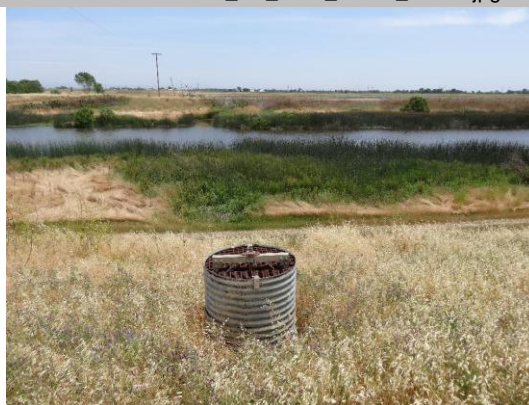
Photo 1 of 3 : UCIP_SP_2017_14223_23445.jpg

LM Start	2.03	Rating **	M	Issue No.	48
LM End	2.03	Issue Type +	En	Location *	LS
Category	Supplemental			GPS Latitude/Longitude	
				Start	End
Item	DWR UCIP Field Study			38.859601 °	38.859601 °
				-121.524885 °	-121.524885 °
DWR ID					
Comment Code					
Inspector Comment					
FS_ID:14223					
DS_ID:22616					
EP_NO: N/A					
Repair Type: Non-Urgent					
Crossing Status: Found					
UCIP Comments: - pipe buried/submerged on LS- needs cleaning of LS pipe end opening.					
FIELD_STRUCT_DESC: 24-inch corrugated-metal drainage pipe through the levee, 15.5 feet below the crown, slide gate in a 36-inch corrugated-metal pipe riser on the waterward slope, concrete headwall at the landward toe, the pipe crosses under the channel					
FS Date: 5/15/2013

WS- slide gate in CMP riser on levee slope.

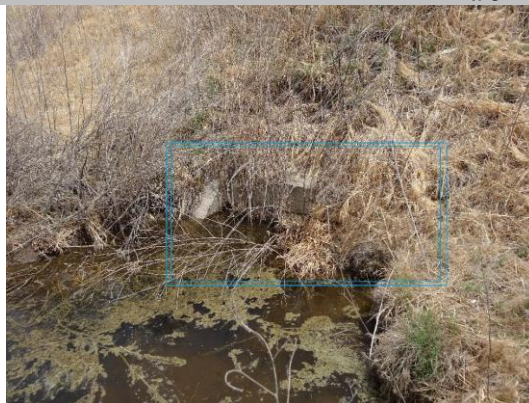
Photo 2 of 3 : UCIP_SP_2017_14223_23444.jpg

LS- concrete wing wall on levee toe

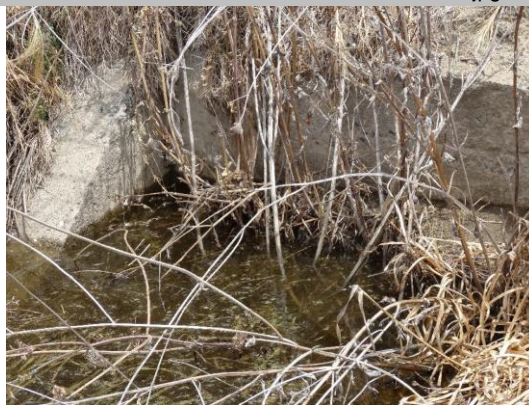
Photo 3 of 3 : UCIP_SP_2017_14223_23443.jpg

LS- pipe submerged/buried in concrete wing wall on levee toe

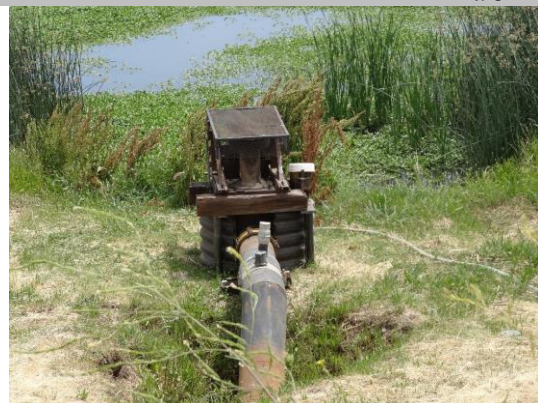
Photo 1 of 3 : UCIP_SP_2017_50692_23427.jpg

Comment Code					
Inspector Comment					
FS_ID:50692 DS_ID:22622 EP_NO: 12208 Repair Type: Urgent Crossing Status: Found UCIP Comments: 07/13/2016 Depression on WS berm has been backfilled, but the cause of the erosion was not addressed to my knowledge. As such, pipe integrity problem may still exist. Vegetation growth surrounds pipe on WS berm, in strike contrast to dry grass away from pipe alignment. This could be due to channel draining toward the pipe, or an indication of pipe leakage. (K. Fazel - UCIP)05/15/2013:- large pit at pipe daylight on WS berm, may be due to pipe leakage.- siphon breaker on LS shoulder not found. (P. Amatya - DWR) FIELD_STRUCT_DESC: 16-inch steel irrigation pipe through the levee, 3 feet below the crown. 16-inch low-lift pump in the channel with a 1-inch electrical line also penetrating the levee to the power pole off the landside (LS) toe. 36-inch corrugated metal pipe (CMP) riser on the bank. Vent on the LS shoulder. Siphon breaker/vent on the apex of the pipe near the WS pump. Standpipe off the LS toe. Pipe used seasonally only in the absense of groundwater, as per district president Joe Henderson. (Permit No. 12208, 1977 - Cuguet). [Additional Reference(s): DWR Levee Log, 1993] FS Date: 7/13/2016

WS- pump and pipe on river bank

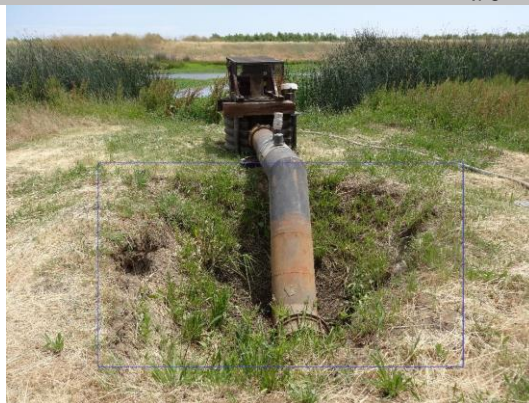
Photo 2 of 3 : UCIP_SP_2017_50692_23429.jpg

Comment Code					
Inspector Comment					
FS_ID:50692 DS_ID:22622 EP_NO: 12208 Repair Type: Urgent Crossing Status: Found UCIP Comments: 07/13/2016 Depression on WS berm has been backfilled, but the cause of the erosion was not addressed to my knowledge. As such, pipe integrity problem may still exist. Vegetation growth surrounds pipe on WS berm, in strike contrast to dry grass away from pipe alignment. This could be due to channel draining toward the pipe, or an indication of pipe leakage. (K. Fazel - UCIP)05/15/2013:- large pit at pipe daylight on WS berm, may be due to pipe leakage.- siphon breaker on LS shoulder not found. (P. Amatya - DWR) FIELD_STRUCT_DESC: 16-inch steel irrigation pipe through the levee, 3 feet below the crown. 16-inch low-lift pump in the channel with a 1-inch electrical line also penetrating the levee to the power pole off the landside (LS) toe. 36-inch corrugated metal pipe (CMP) riser on the bank. Vent on the LS shoulder. Siphon breaker/vent on the apex of the pipe near the WS pump. Standpipe off the LS toe. Pipe used seasonally only in the absense of groundwater, as per district president Joe Henderson. (Permit No. 12208, 1977 - Cuguet). [Additional Reference(s): DWR Levee Log, 1993] FS Date: 7/13/2016

WS- large depression on levee berm

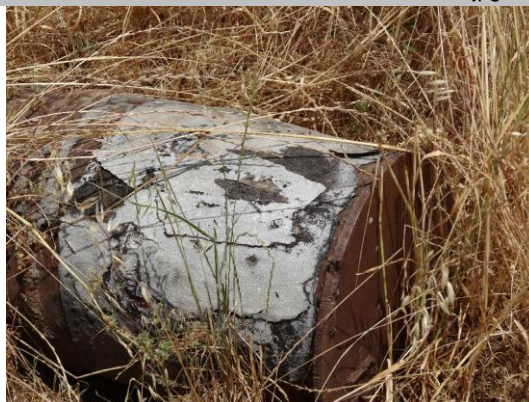
Photo 2 of 3 : UCIP_SP_2017_41674_23381.jpg

WS- an abandoned end capped pipe on levee slope

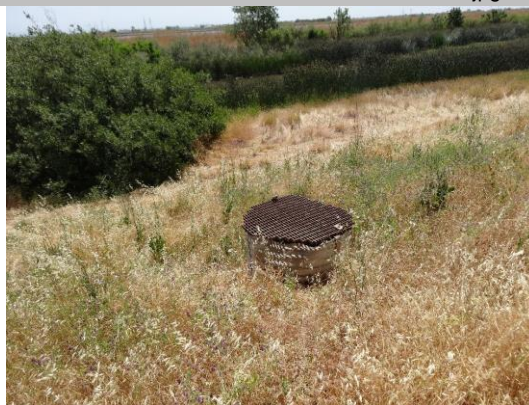
Photo 3 of 3 : UCIP_SP_2017_14167_23397.jpg

WS- slide gate in CMP riser on levee slope

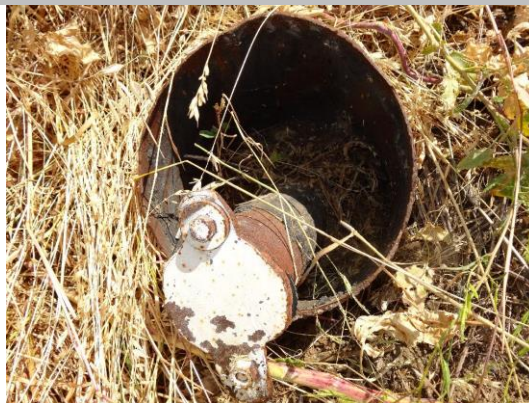
Photo 2 of 2 : UCIP_SP_2017_13523_22120.jpg

WS- gap between two pipes needs to be filled.

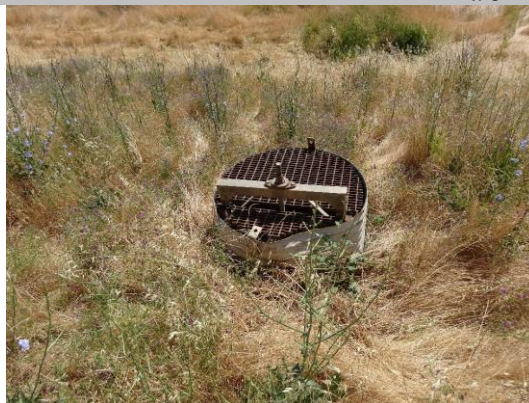
Photo 1 of 2 : UCIP_SP_2017_13509_22086.jpg

WS- fixed slide gate in CMP riser on levee slope.

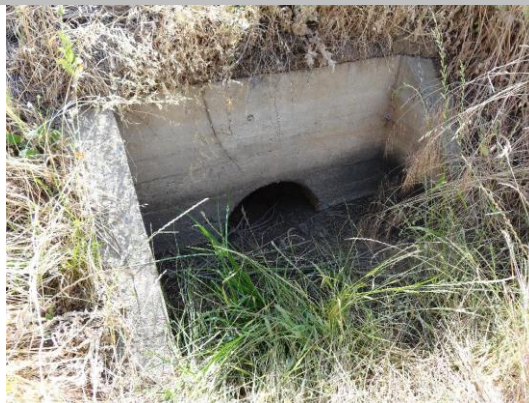
Photo 2 of 3 : UCIP_SP_2017_50699_22045.jpg

LS- CMP in concrete head/wing wall outlet

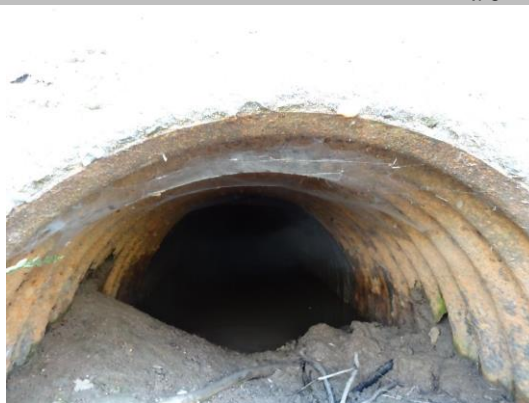
Photo 3 of 3 : UCIP_SP_2017_50699_22044.jpg

Comment Code						
Inspector Comment						
FS_ID:50699 DS_ID:22632 EP_NO: N/A Repair Type: Urgent Crossing Status: Found UCIP Comments: 07/13/2016 Same condition as last. Pipe heavily corroded and partially filled with debris and straw. (K. Fazel - UCIP) 05/15/2013:- mud/soil debris on LS pipe end.- highly corroded pipe in outlet.- may require video inspection or pressure test. (P. Amatya - DWR) FIELD_STRUCT_DESC: 24-inch corrugated metal drainage pipe through the levee, 12.2 feet below the crown. Slide gate in a 36-inch corrugated metal pipe (CMP) riser on the waterside (WS) slope. Concrete headwall at the landside (LS) toe. The pipe crosses under the channel. [Additional Reference(s): DWR Levee Log, 1993] FS Date: 7/13/2016

LS- highly corroded and damaged CMP in concrete head/wing wall outlet

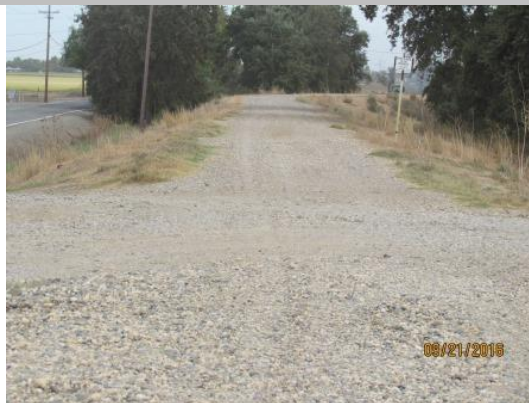
Photo 1 of 1 : SP_2017_RD1001_40_19_20170316_00005.jpg

LM Start	4.33	Rating **	A/W	Issue No.	19
LM End	4.33	Issue Type +	Ma	Location *	CR
Category	Earthen Levee			GPS Latitude/Longitude	
				Start	End
Item	Crown Surface / Depressions / Rutting			38.892999 °	38.892999 °
				-121.524711 °	-121.524711 °
DWR ID	DWR_RD1001_06_f_2013_19				
Comment Code					
C2 : Repair depressions or ruts in the crown or slope.					
Inspector Comment					
Crown where there is cross traffic. Monitor this area and fix as needed.

View of crown where there is cross traffic looking upstream. Monitor this area and fix as needed.

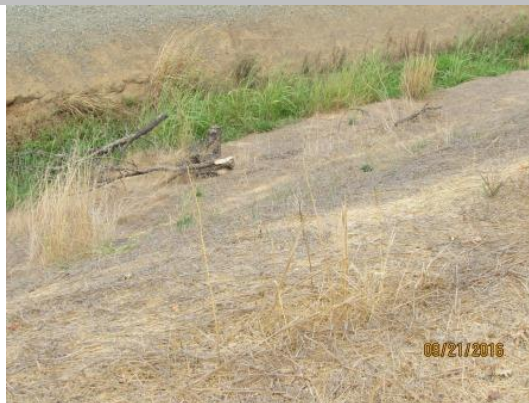
Photo 1 of 1 : SP_2017_RD1001_40_22_20170316_00007.jpg

LM Start	4.38	Rating **	N	Issue No.	22
LM End	4.38	Issue Type +	Ma	Location *	LS
Category	Earthen Levee			GPS Latitude/Longitude	
				Start	End
Item	Trim / Thin Trees			38.893728 °	38.893728 °
				-121.524715 °	-121.524715 °
DWR ID	DWR_RD1001_06_f_2016_22				
Comment Code					
T5 : Tree stumps.					
Inspector Comment					
A stump at the landside levee toe.

View of a stump at the landside levee toe. Fall 2016.

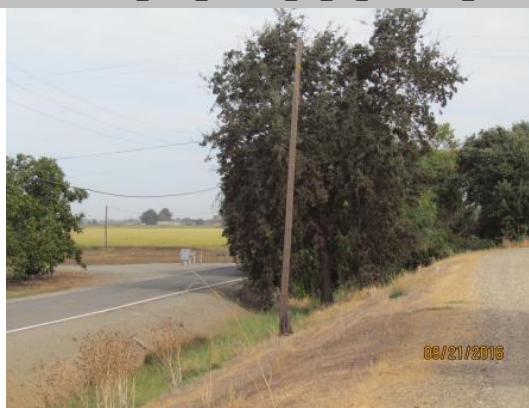
Photo 1 of 1 : SP_2017_RD1001_40_23_20170316_00008.jpg

LM Start	4.43	Rating **	A	Issue No.	23
LM End	4.43	Issue Type +	En	Location *	LS
Category	Earthen Levee			GPS Latitude/Longitude	
				Start	End
Item	Encroachments			38.894403 °	38.894403 °
				-121.524718 °	-121.524718 °
DWR ID	DWR_RD1001_06_f_2016_23				
Comment Code					
PO : Pole					
Inspector Comment

View of pole on the landside levee slope looking upstream. Fall 2016.
